RODEO GROUNDS BERM REMOVAL PROJECT

OAK TREE REPORT

**NATIVE TREE PRESERVATION AND
REMOVAL PLAN**

AUGUST 2006

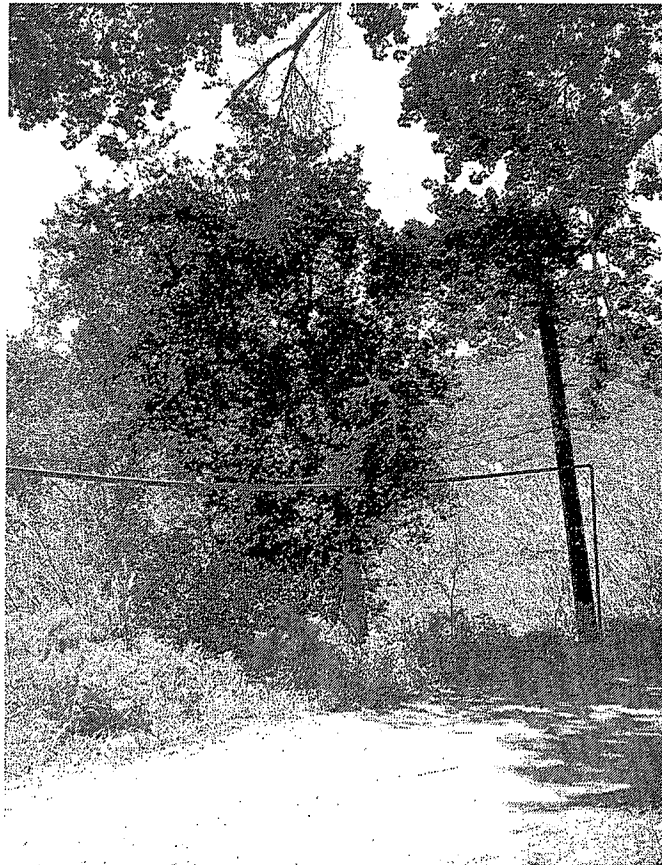
Figure 2. Tree # 1, Coast Live Oak

Site condition: Located on the upper edge of the west bank of fill material, directly under the canopy of the mature cottonwood.

Condition rating: Good – 72%

Pests and diseases: No significant problems

Reason for Removal: Given the location at the upper edge of the fill material, it will not be possible for the tree to remain once the fill material is removed. Although the tree is in good condition, moving the tree is not recommended, as this is costly, would require significant investment in long term maintenance, and has a high incidence of failure.

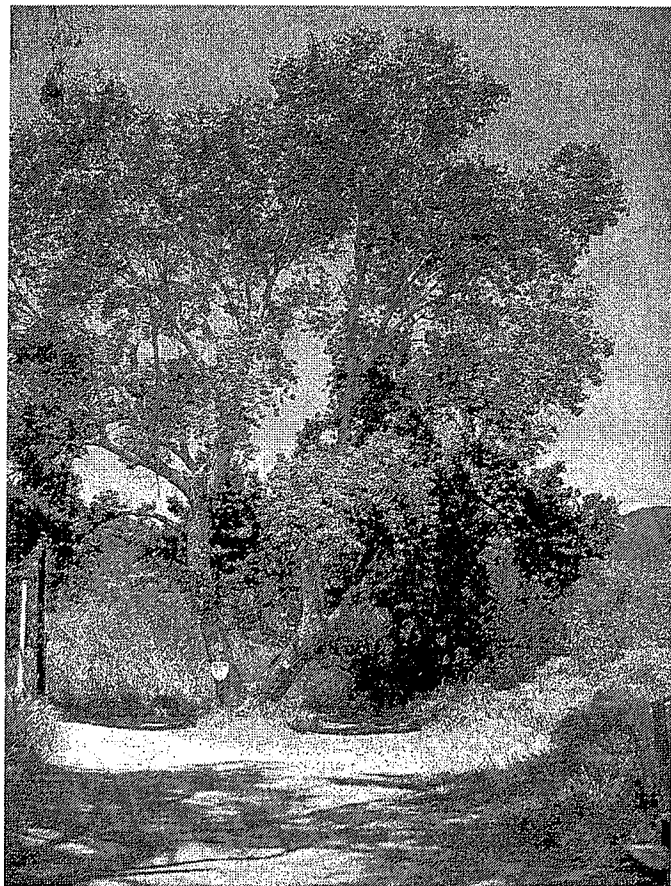
Figure 3. Tree # 2 Mature Cottonwood, south side April 2005

Site condition: It is located totally within the fill, and is approximately 50 feet from the edge of the creek on the east, and approximately 100 feet from the channel to the south.

Condition Rating: Poor – 44%

Pests and Diseases: Over 80% of the trunk showed evidence of decay at the ground level, with additional evidence of widespread rot apparent in exudations, branch failure, twig dieback, foliage covered with brown spots, and fruiting bodies in old wounds.

Reason for Removal: The trunk of this tree has been buried in over 14 feet of fill since at least 1969. Preliminary evaluation of the trunk/ground interface indicates widespread decay. Additional evaluation at the time of excavation should be attempted to characterize the structural stability of the trunk further below ground, and the decision for removal made at that time.

Structural Condition: It was not possible to evaluate the structural condition of either the main trunk or the roots, as they are buried in fill. Therefore this condition rating reflects only the structural condition of the scaffold branches which have effectively become the trunks, and the canopy.

There are several large broken branches in the upper canopy, which could be the result of wind damage. There are also several dead branches in the canopy. The distribution of vertical branches is typical of the species. Many of the larger branch attachments have included bark. The branches that failed did so outside the branch collar, leaving shredded stubs subject to decay. Wounds from recently pruned branches have not yet begun to form wound wood, although old scars are well covered. The crown is open, with approximately 60% cover and there are a few signs of the start of mainstem dieback.

Health: Exudations located at areas of included bark, as well as along the side of the eastern branch point to widespread disease. Fruiting bodies were found emerging from several old wounds.

Additional exploratory excavation by a qualified arborist should be performed during the berm removal in order to assess the condition of the trunk prior to implementation of any tree preservation strategies. If the trunk is further compromised within the top 3 feet of the berm fill, it can be assumed that it will probably fail once the berm is removed. If it is sound, then additional excavation may be performed and the preservation strategies implemented.

Since there will be no direct targets in the creek, California Department of Parks and Recreation can then decide to a) remove the cottonwood (#2) and sycamore tree (#4) during the berm excavation; or b) allow the cottonwood and sycamore tree to fail and fall, providing large woody debris in the restored floodplain area.

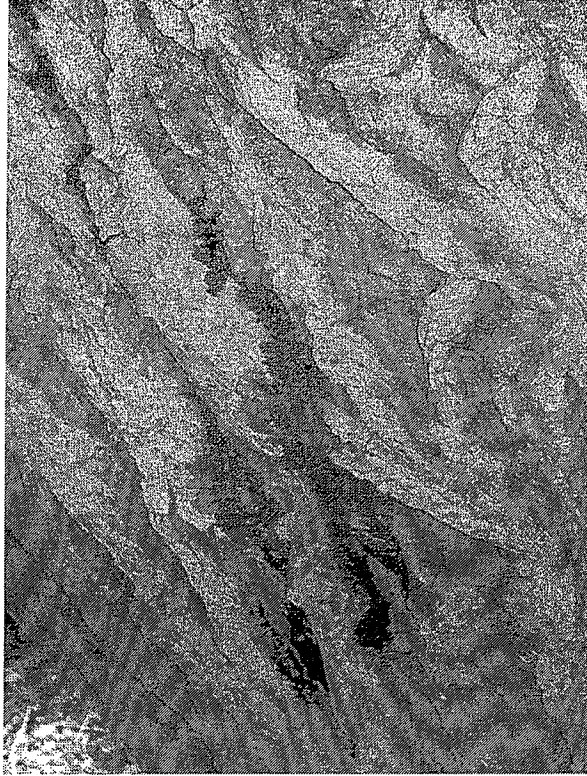
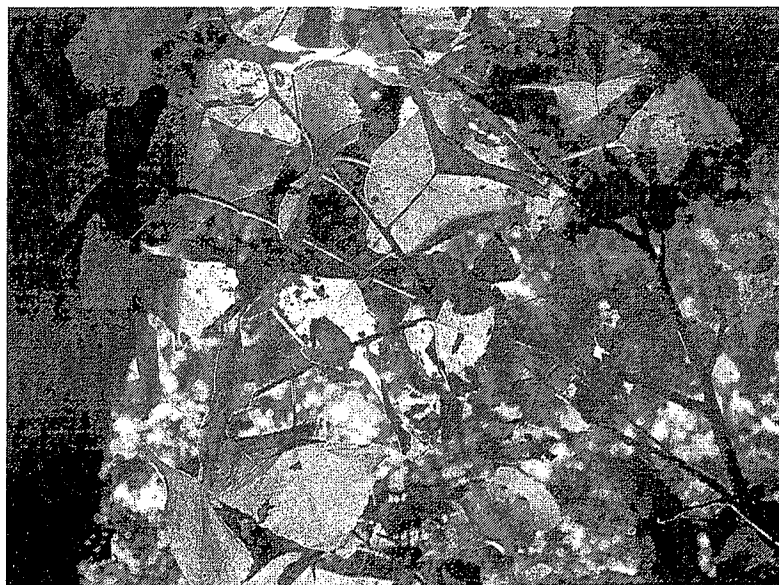
Figure 4. Photographs of exudations and leaf condition

appeared normal when it sprouted in the spring, but has become infected with brown spots as the season progressed, with significant leaf drop and wilting evident.

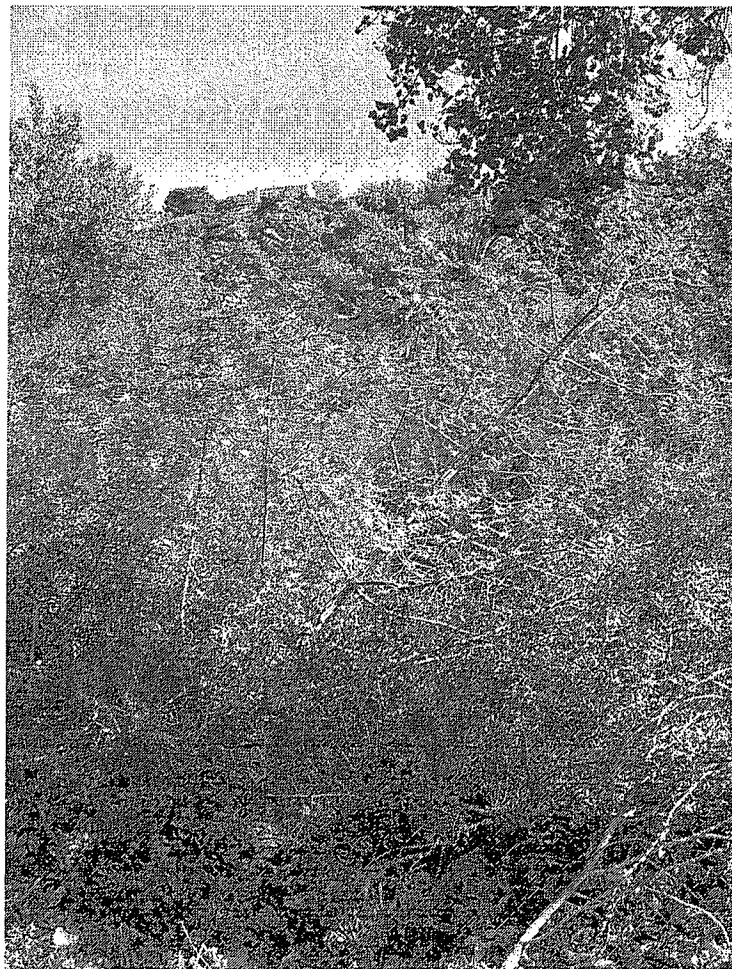
Figure 5. Tree # 3. CA Walnut (*Juglans californica*)

Site condition: Located at the top of the east fill bank, within the grouted riprap.

Condition rating: Fair- 68%

Pests and diseases: some loss of upper canopy leaves to insect herbivory. Trunk bark cracked.

Reason for Removal: Given the location at the upper edge of the fill material, it will not be possible for the tree to remain once the fill material is removed. Although the tree is in fair condition, moving the tree is not recommended, as this is costly, would require significant investment in long term maintenance, and has a high incidence of failure.

Although this is a relatively small tree, the loss of CA Walnuts throughout their range suggests that a minimum replacement planting of three one gallon trees, as well as 10 nuts in tree tubes. Nuts should be gathered from within the watershed.

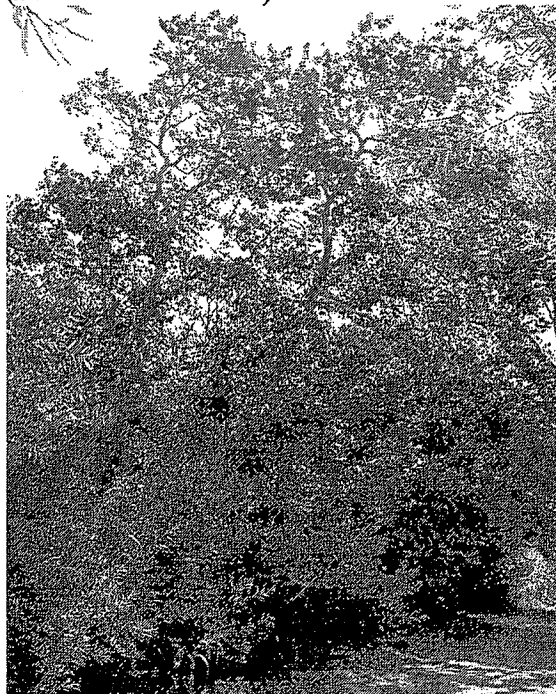
Figure 6. Tree # 4. Sycamore Tree (*Platanus racemosa*)

Site condition: Located on the upper edge of the east side of the berm above grouted riprap.

Subject Tree Observations: This multi-trunk tree is located where it may be possible to create a small island of remaining fill to support the tree.

Condition Rating: Good – 72%

Pests and diseases: Anthracnose present.

3. Material should first be removed with hand tools within a six foot radius of the trunk to locate structural roots. Based on distribution of roots and trunk condition uncovered, the arborist can advise the crew if use of a bobcat or other excavation machine is possible without compromising the tree. If not, then excavation should be confined to hand tools.

4. If there is a question of tree stability once the fill material is removed, the arborist shall work with the CDPR ecologist to determine if the tree should be removed or retained and either allowed to fail under natural conditions or supported by bracing or cabling.

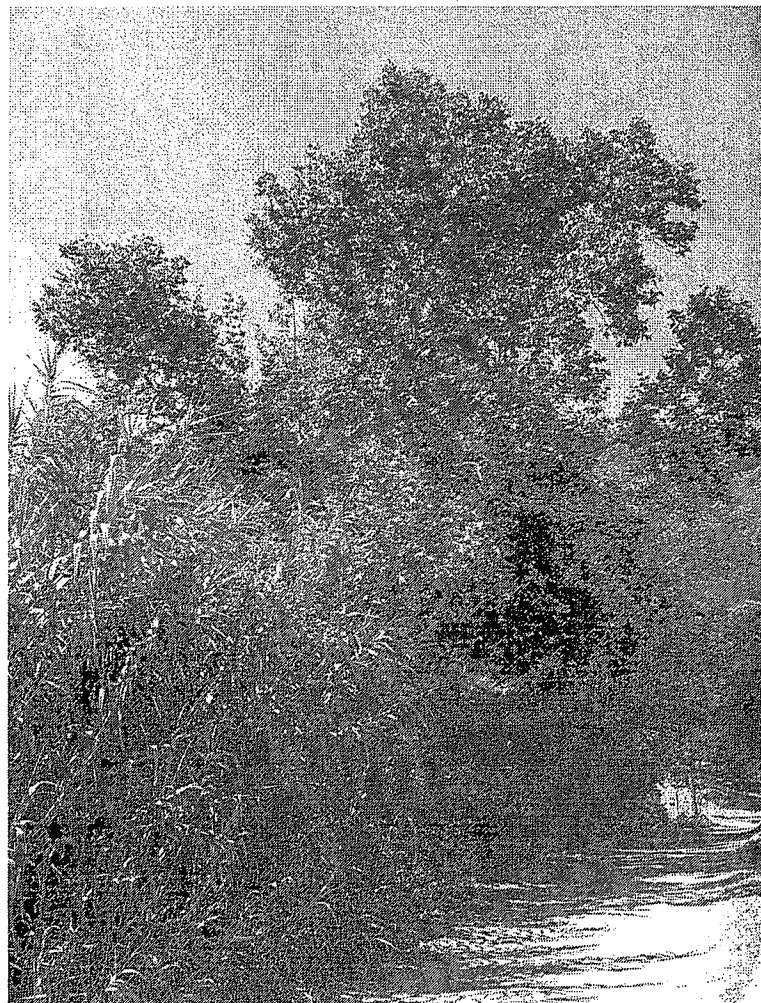
**Figure 7. Tree #5 Sycamore Tree (*Platanus racemosa*)
Looking northwest**

Site condition: Located along the side of the west bank, below obvious riprap.

Condition Rating: Fair – 68%

Pests and diseases: Anthracnose

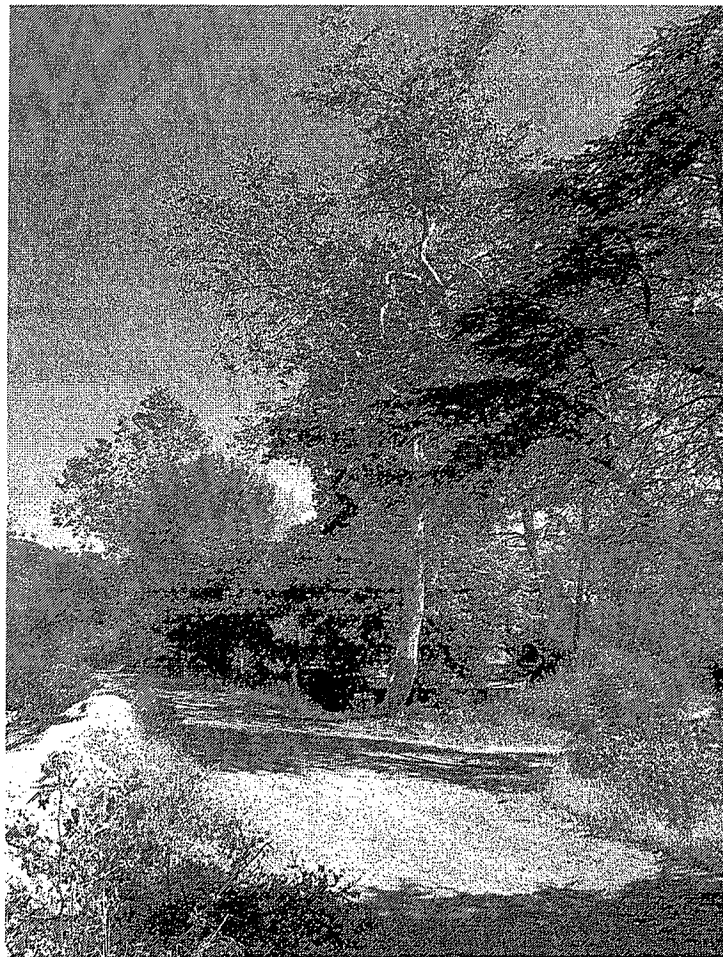
Figure 8. Tree #5. Sycamore Tree (*Platanus racemosa*)

Site condition: Located on the corner of the berm and an unpaved road. A two foot high gunnite wall separates the edge of the roadway and the trunk.

Condition Rating: Fair – 53%

Pests and diseases: Anthracnose

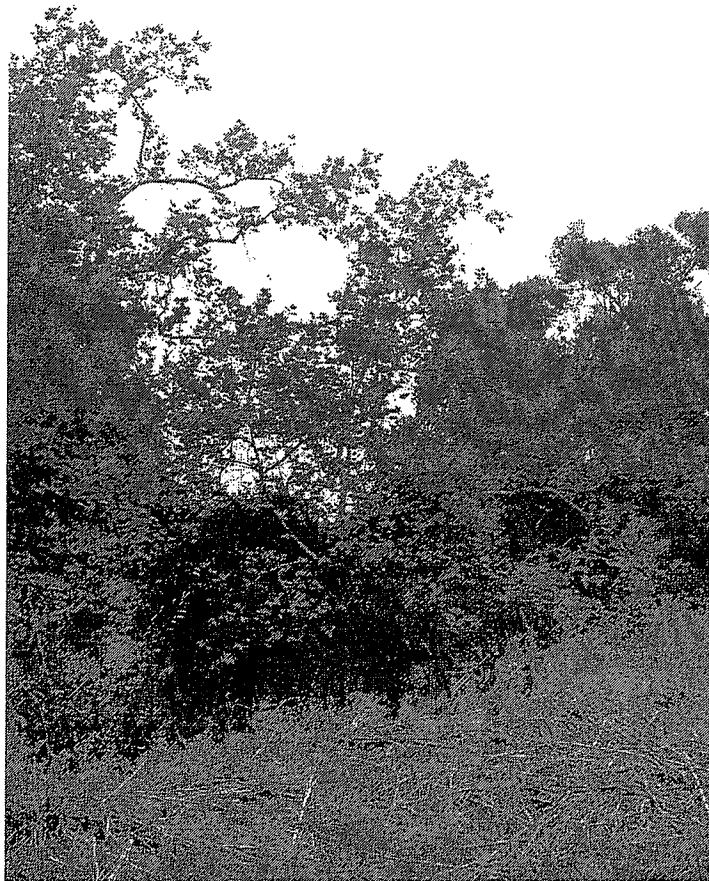
Figure 9. Tree #7. Sycamore Tree (*Platanus racemosa*)

Site condition: Located behind the southwest corner of the berm and an unpaved road.

Condition Rating: Good - 72%
Pests and diseases: Anthracnose

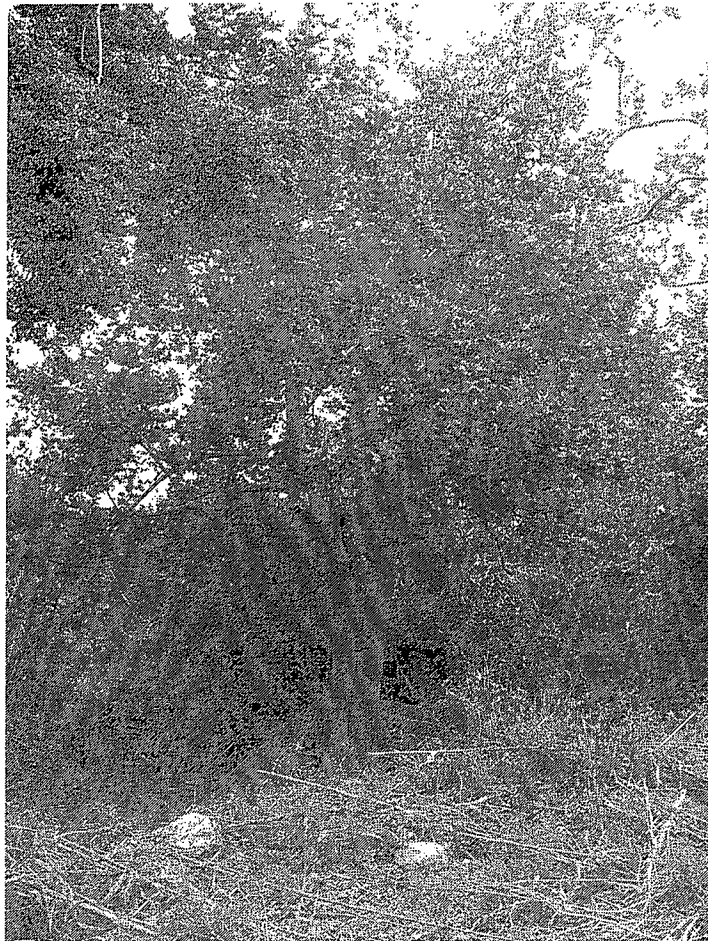
Figure 10. Tree #8. Sycamore Tree (*Platanus racemosa*)

Site condition: Located on a small rise southeast of the berm near an unpaved road.

Condition Rating: Fair – 56%

Pests and diseases: Anthracnose, boring beetles in trunk up to 6 feet

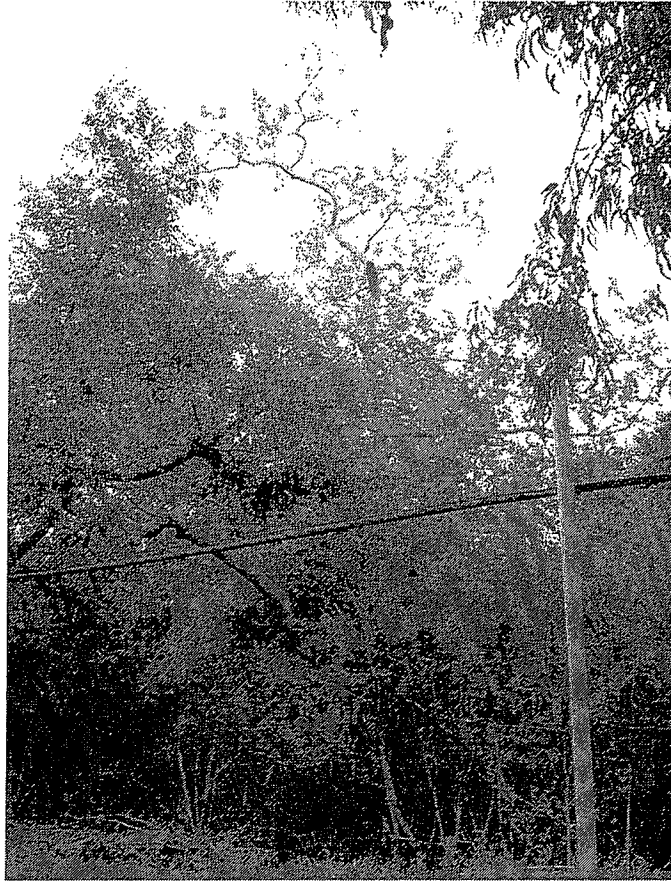
Figure 11. Tree #9. Sycamore Tree (*Platanus racemosa*)

Site condition: Located on the southwest corner of the berm.

Condition Rating: Fair – 64%

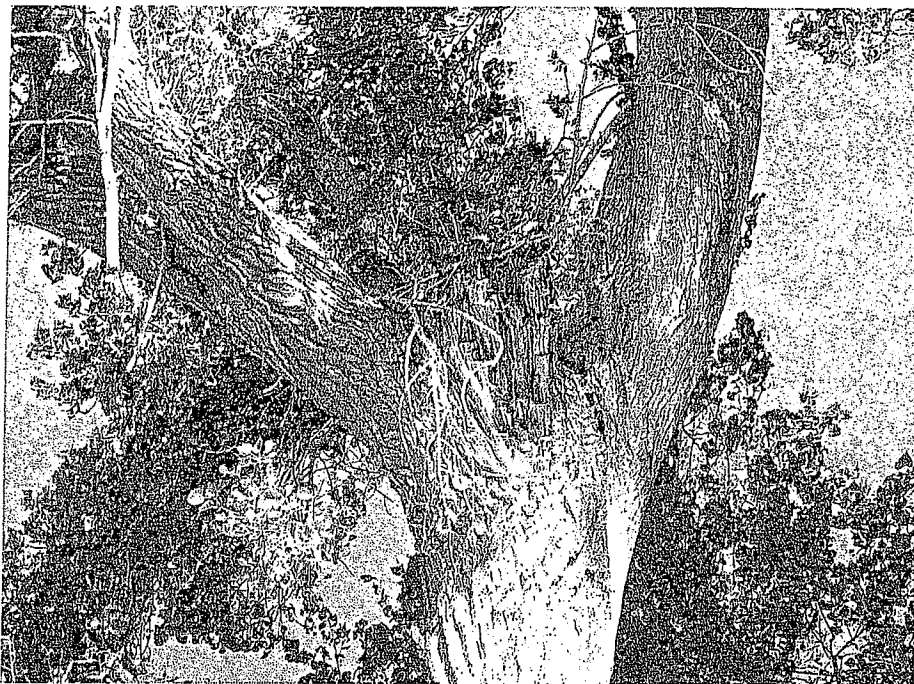
Tree #2 Broken branch in upper canopy

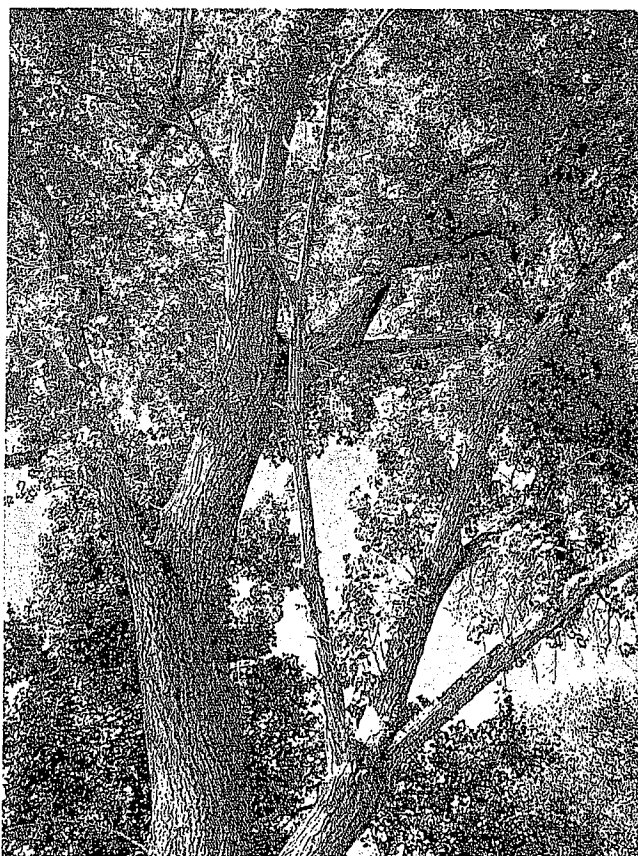
Tree #2 Exudate and dead branches in upper canopy

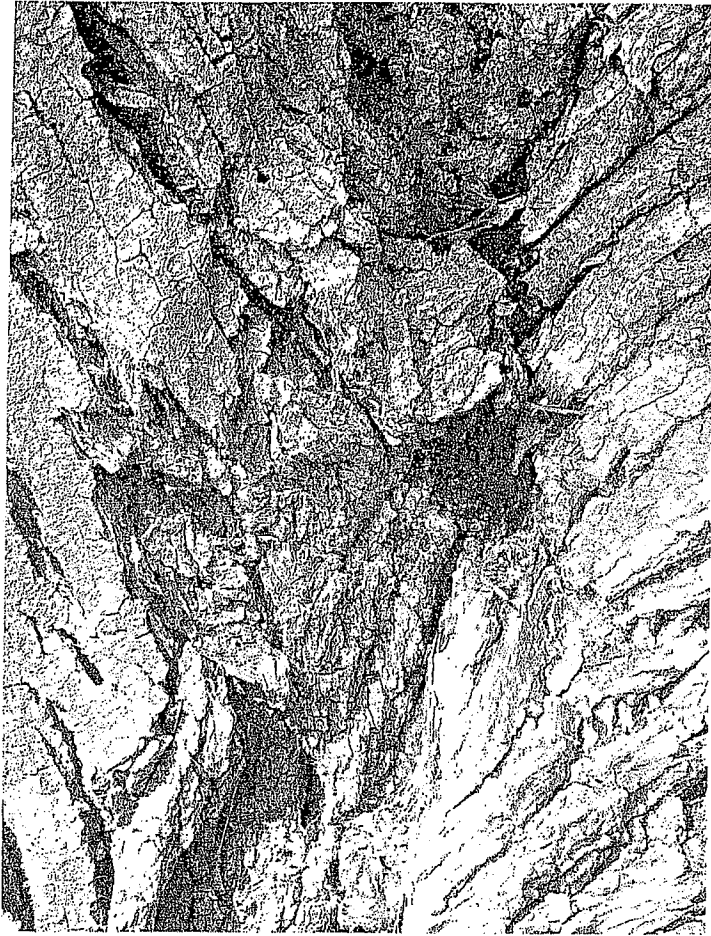
Tree #2 Decay in crotch near ground

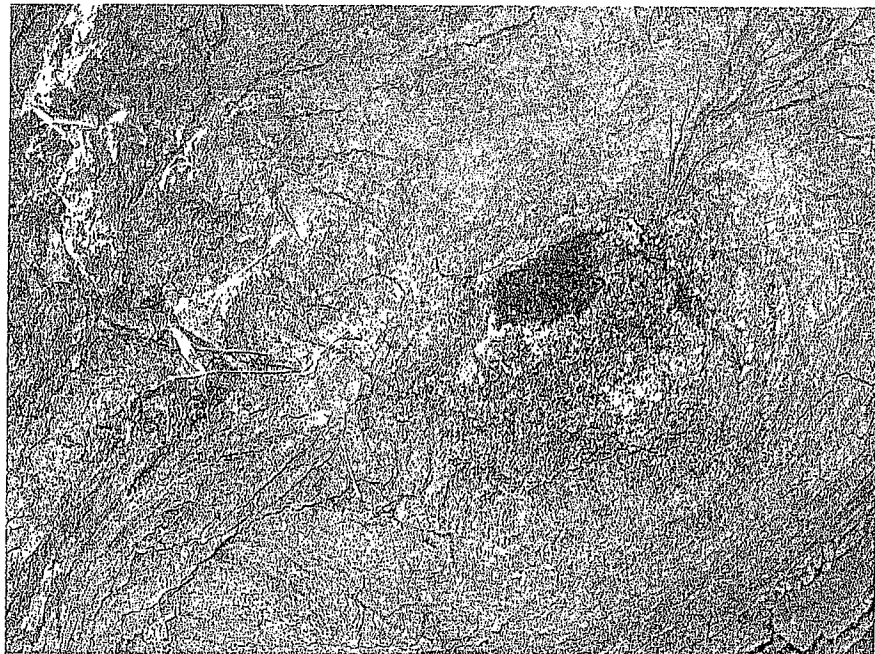
Tree #2 Fungal fruiting body in old branch scar

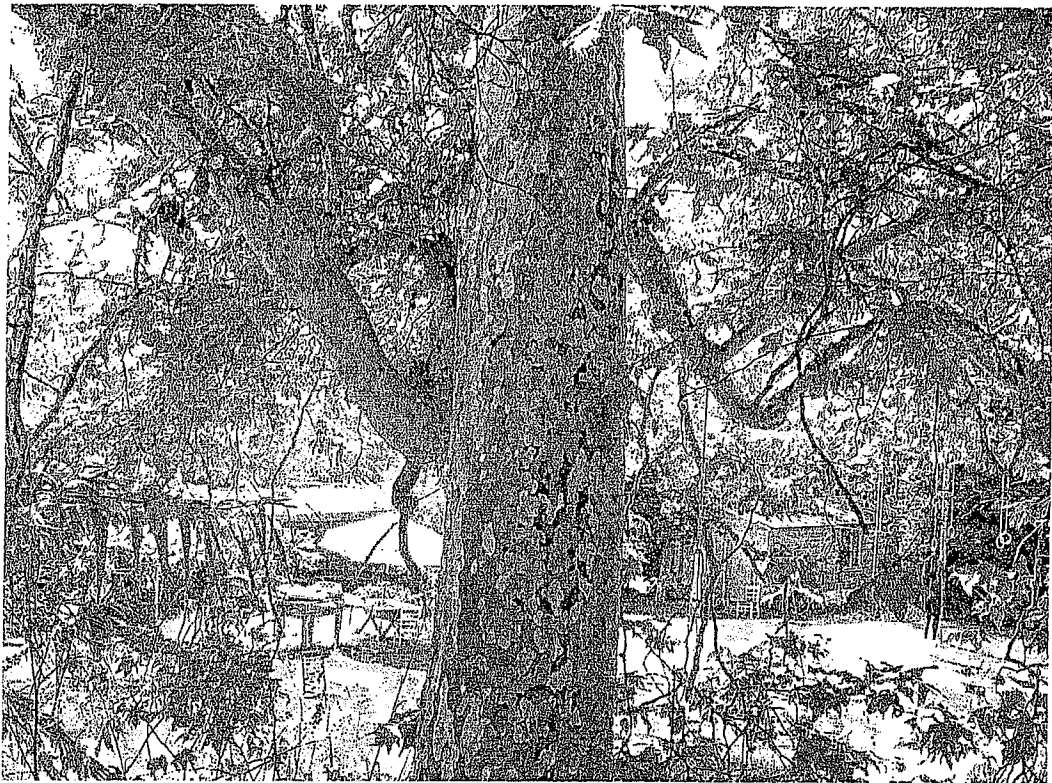
Tree #5 Unusual branch attachments on Sycamore

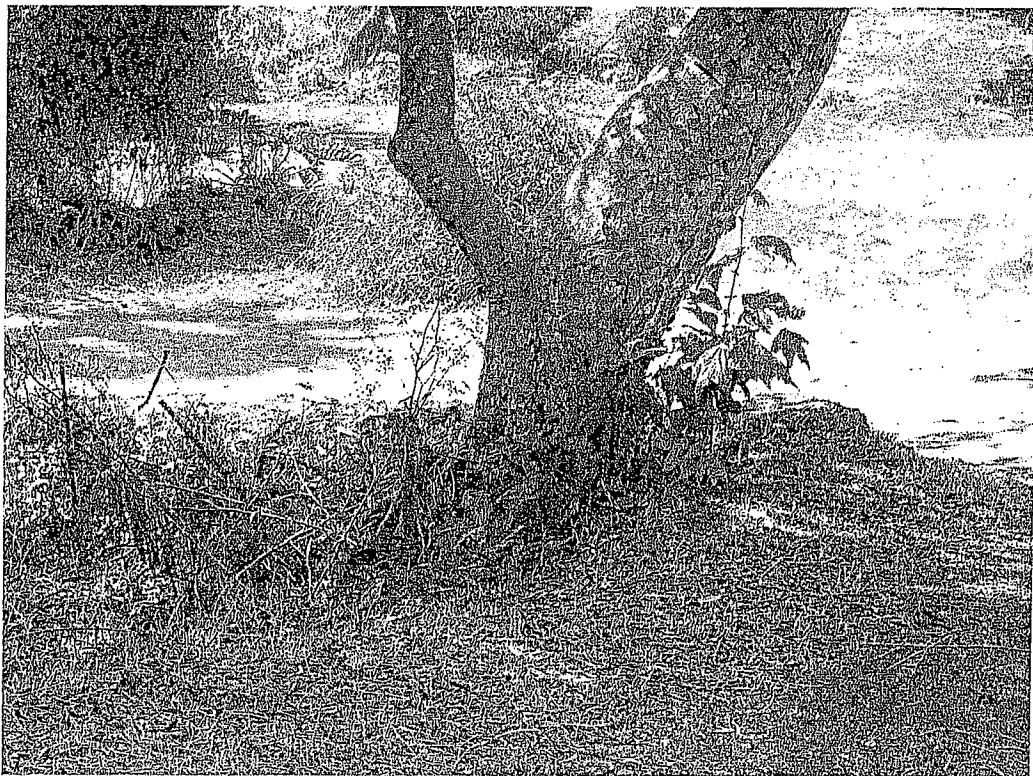
Tree #6 Sycamore to remain, illustrating root zone

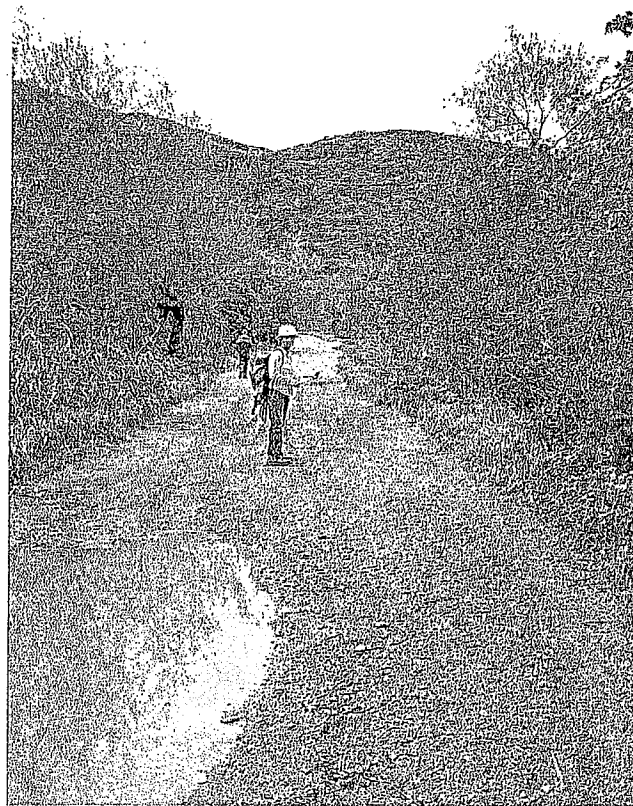
Top of berm showing willow thickets
